# Diagnosis of solid waste disposal area in Paiçandu (Brazil) and proposal for improvements

Estrabão  
Vol(2):86 – 105  
©The Author(s) 2021  
DOI: 10.53455/re.v2i.10

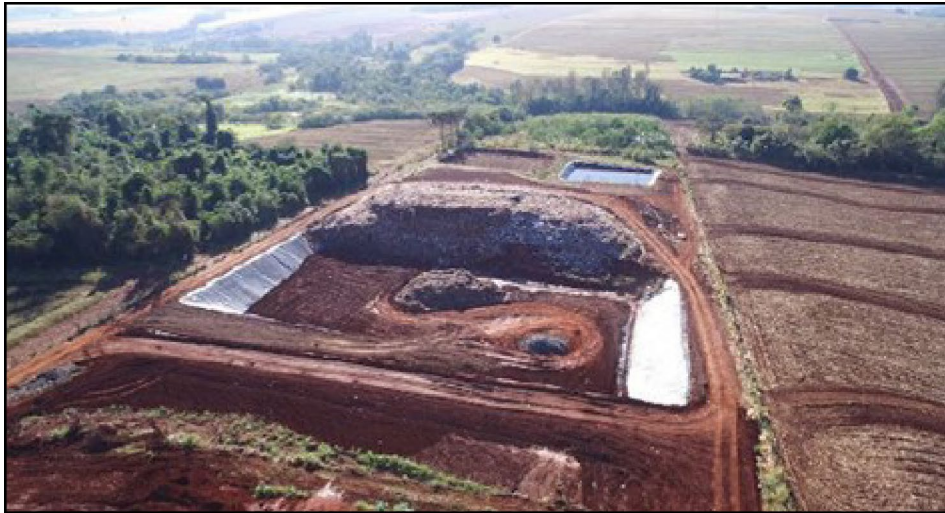
**Figure 3.** Existing ditch in the solid waste final disposal system

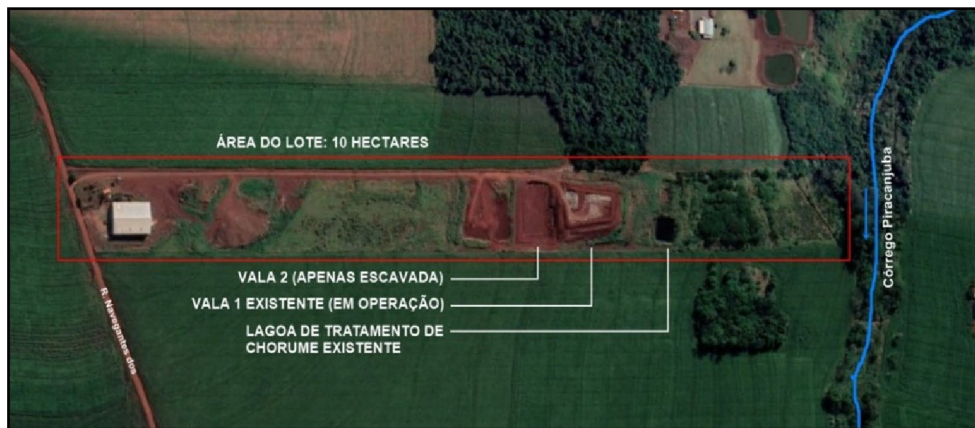
The site where the solid waste final disposal system operates has an area of approximately ten hectares (Figure 4) and, according to Rosado (2018), receives around 652 tons per month. According to Ordinance No. 259 (PARANÁ, 2014), it is classified in category "A" (waste receiving capacity less than 200 tons per day).

**Figure 4.** Aerial image of the waste final disposal of Paiçandu, PR, Brazil

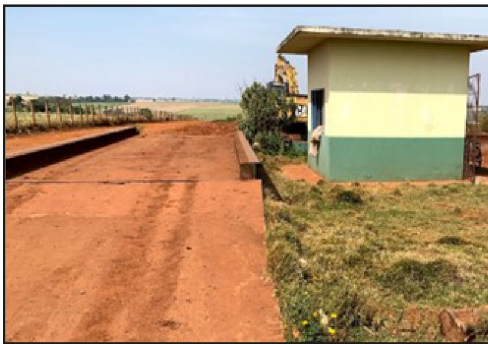
The existing balance has a structure on the side for operating its machinery (Figure 6); however, it is not operational due to the theft of parts. The municipality outsources a large portion of the necessary machinery to operate the site, and there are not enough employees for all the functions required for a good operation. Right at the entrance to the lot, there is a water tank and an artesian well that has allocation according to the responsible technician.

**Figure 5.** Balance

ITEM	IMPROVEMENT PROPOSALS
- Balance	- Acquire the missing parts for the garbage weighing operation
- Fencing	- Install fencing around the entire perimeter of the lot

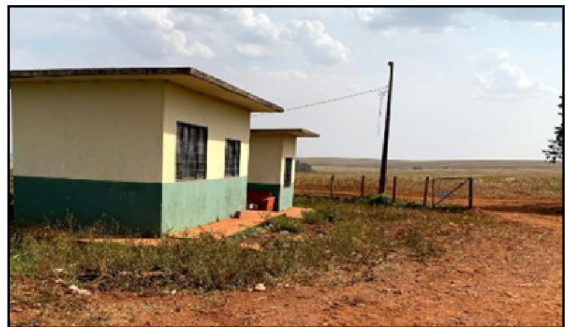
At the entrance to the site, there is a structure intended for the security cabin and another for locker rooms and restrooms (Figure 5). However, there are no reception employees at the security cabin. There is a housekeeper who takes care of the site and lives there.

**Figure 6.** Lot entrance

ITEM	IMPROVEMENT PROPOSALS
- Entrance	- Hire/assign an employee to the proper role of a gatekeeper
-	- Hire/assign employees to the surveillance and security of the site
Surveillance	
- Balance	- Hire/assign an employee with mastery of the equipment for handling and operation
- Machinery	- Acquire machinery with the purpose of minimizing expenses with outsourced equipment

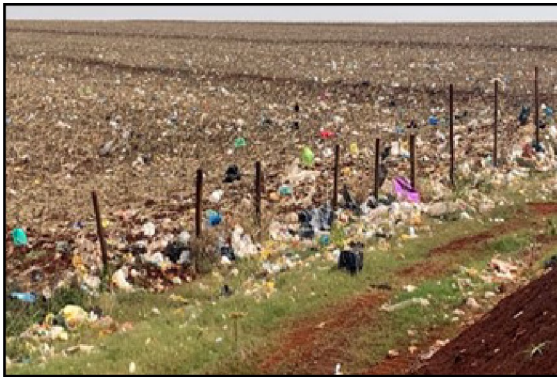
According to standard NBR 13896 (ABNT, 1997), the site does not have appropriate fencing for the type of work operated. Moreover, there is no green curtain (Figures 7 and 8). Another factor to be analyzed is how close the electrical wiring passes to the lot border and, for this reason, may be an obstacle for the implementation of the green curtain. The number of plastic bags dispersed outside the ditch is high. With this, there is a concern with the neighboring lot, which carries out seasonal plantations.

**Figure 8.** View of the neighboring lot

Moreover, there must also be a green belt with the purpose of blocking the view of the operational area, dispersing the foul smell of the garbage, and preventing plastic bags and other objects from flying outside the site limits, as per Monteiro et al. (2001), Figures 13 and 14.

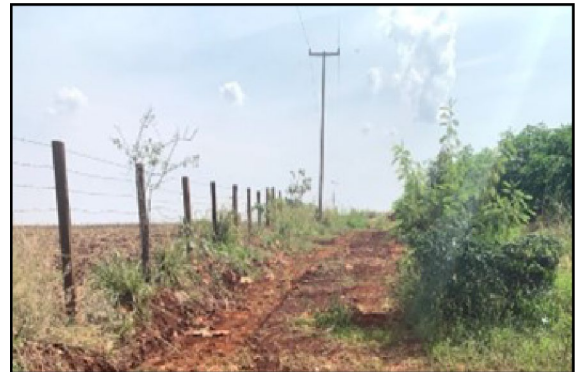
**Figure 7.** Existing fencing

To avoid the entrance of unauthorized people to the landfill area, the installation of fencing around the entire perimeter of the lot is advised. It is recommended that this fence has approximately 2 m in height, with concrete fence posts through which galvanized or barbed wire passes with homogeneous spacing.

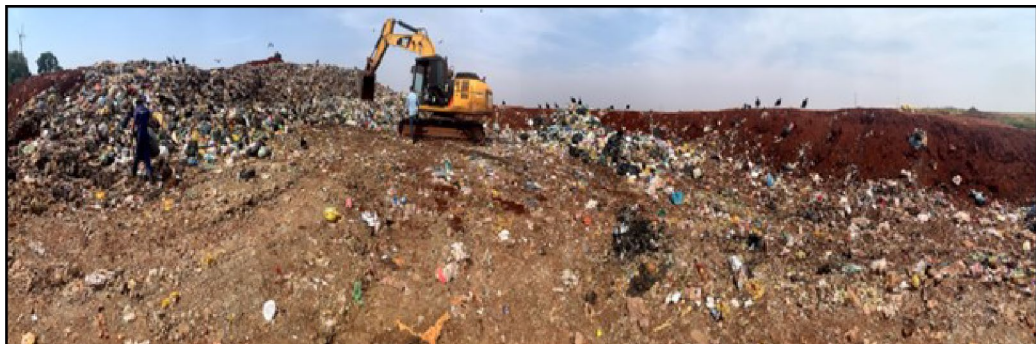
In an interview with the technician, the information regarding the current situation of the site is that Ditch 1 (Figure 9) had already become saturated for one year and a half. The requests for constructing a new ditch, among other necessary adaptations for the site, were filed in advance; however, the procedure to execute the orientations was/is quite bureaucratic.

**Figure 9.** Ditch 1

Therefore, over time, it was necessary to execute some urgent readjustments and, unfortunately, some irregularities emerged, such as superposed cells of the existing ditch even after its service life ended, and the excavation and covering with large-sized crushed stone at the leachate drainage intersection point, which took place because the leachate drain intersection point was compromised and blocked, so a procedure was executed where there was an excavation, the location/pipe was repaired, and a layer of crushed stone was put in so not to block the leachate drainage completely.

The leachate drainage of Ditch 1 is not fully effective; when observing the leachate inspection well, the flow that goes by and is destined for the pond is small compared to the size of the existing ditch, so one may conclude that the piping is partially blocked somewhere. The geomembrane of the leachate treatment pond (Figure 10) is damaged at some points (Figures 11 and 12). Therefore, there is a risk of damage to the soil if its level rises to the damaged sites. The rainwater drainage is carried out through level curves of the land. Therefore, there is no rainwater channeling structure to a predetermined container.

Considering the urgency in shutting down Ditch 1, it is important to stress that the procedure must be executed with caution since the cell is beyond the limit of its capacity to receive solid waste. Hence, the final covering of the cell with about 60 cm of soil and, over this clay layer, the planting of grass

vegetation is recommended. The purpose of this final cover layer is to isolate the waste from the site and reduce rainwater infiltration into the cell. This layer needs to be flexible so to accommodate the displacements that will occur in the future (Reichert & Projeto, 2007).

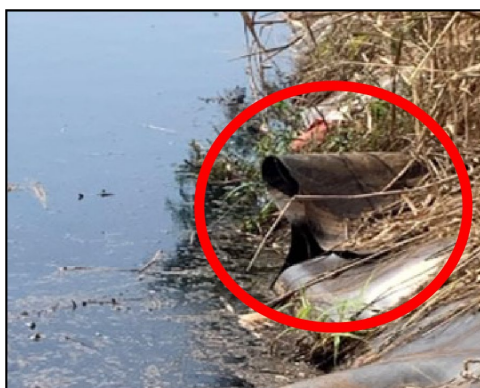
**Figure 11.** Leachate treatment pond

Based on the existing system for leachate treatment, which occurs through leachate recirculation, hiring a specialized company to remove the leachate from the treatment pond is recommended, executing the geomembrane repairs after.

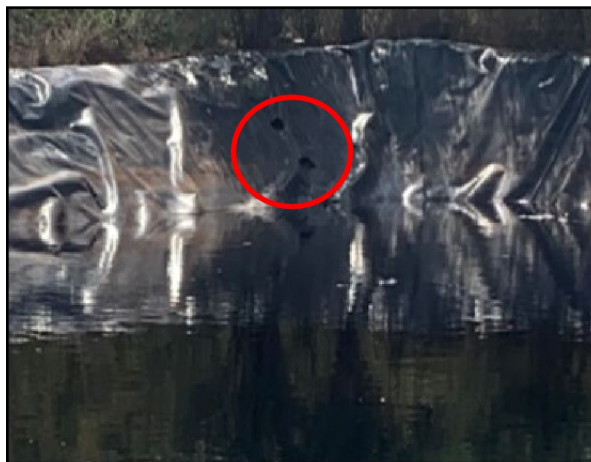
**Figure 12.** Damages to the geomembrane of the leachate treatment pond

The impermeabilization system used to protect the soil is through the installation of an HDPE blanket, generally with 2 mm thickness. The leachate treatment pond is also impermeabilized this way; however, the existing pond is damaged, allowing the risk for soil contamination.

- Damaged geomembrane at the leachate treatment pond	- Execute repairs to the geomembrane
- Leachate treatment	- Hire a specialized company to remove the leachate accumulated on the treatment pond and dispose of it correctly.- Due to the fact there is only the recirculation of the liquid

Relative to the geomembrane damage, it may generally be repaired in several ways depending on the material. However, thermofusion welding is generally used for HDPE geomembranes, which consists of heating the faces to be joined through heat transfer via metallic wedge or air blowing, hence welding the two faces (COLMANETTI, 2006).

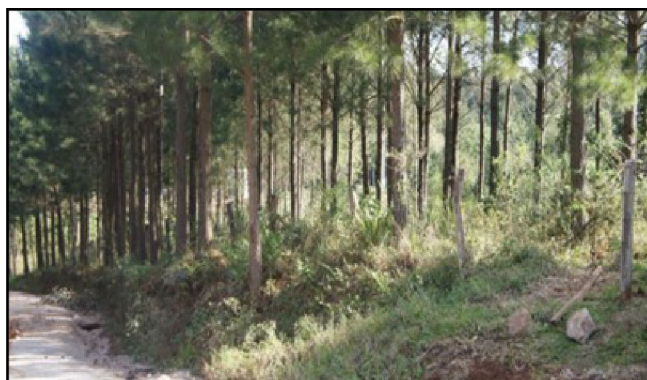
**Figure 13.** Perimeter vegetation

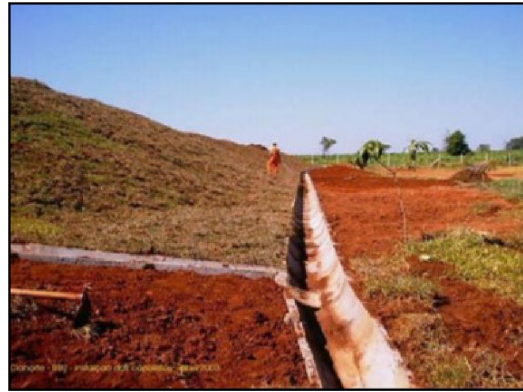
Figure 15. Drainage system that exists in the sanitary landfill of Cianorte by Albertin et al. (2011), PR.

The drainage system needs to be able to support drainage so as to prevent water from accessing the landfill mass and solid and percolated liquid materials from being carried outside the area belonging to the landfill (ABNT, 2010), with the purpose of an appropriate direction for soil infiltration. One of the effective methods for rainwater drainage is the installation of concrete channels (Figures 15 and 16), known as half-round channels.

Standard NBR 8419 (ABNT, 1992) provides guidance about the importance of the existence of a site for discharging the water collected by the surface drainage channels, known as a "rainwater accumulation pond"; it needs to be dimensioned according to the rainfall of the region, landfill area (cell), and the amount of water predicted to be drained through the concrete channels.

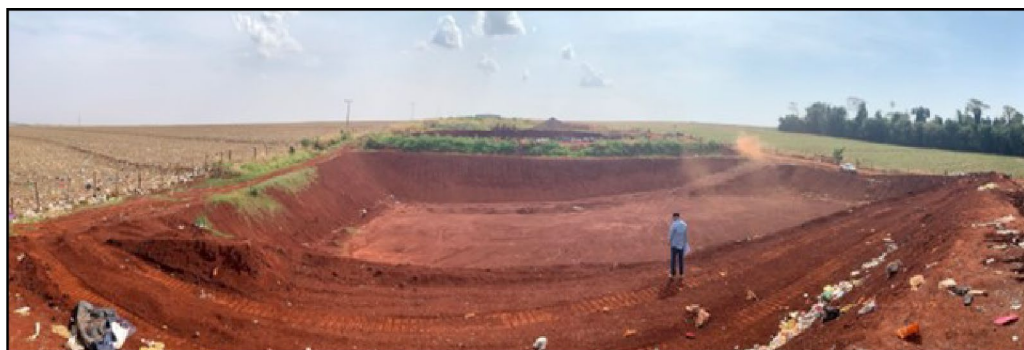
**Figure 17.** Ditch 2

Regarding implementing a new ditch, considering the existing excavation (Ditch 2), as per Figure 17, the urgent implementation of the entire system required to receive waste is advised.
